TECHNICAL BULLETIN

DS7, R5's, RD250, RD350

CLUTCH, Elimination of Slipping

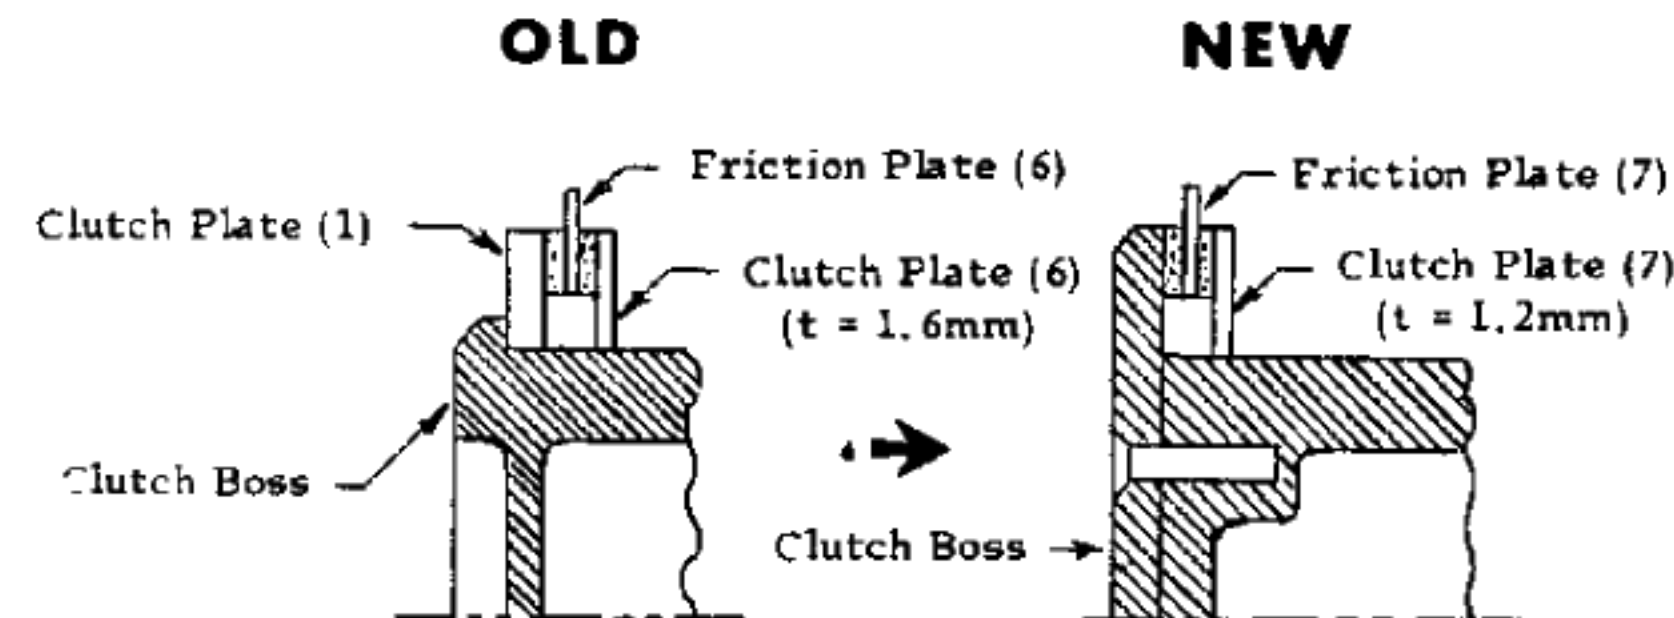
Clutch assemblies on above models have been redesigned to reduce clutch slippage. This change consists of replacing the clutch boss and clutch plates and increasing the number of friction plates from six (6) to seven (7). See table below for both old and new parts list.

The clutch must be assembled with the first friction plate against clutch boss. See drawings below.
